Service Bulletin 4812 718 40309**AUTHOR:** Alicja Malinowska**Last Update:** 03/30/11**VERSION:** 1.0**TITLE:** Integrated heating element Euro/UK (Motor Pump Heater MPH)**SUBJECT:** Integrated heating element Euro/UK replacement**REMEDIAL ACTION**

Service Bulletin 4812 718 40316

TITLE: Open Fuse occurring at integrated heaters used for Motor-Pump-Heater (MPH), and Variable Speed Motor (VSM).

SUJET : Fusible de résistance fondue

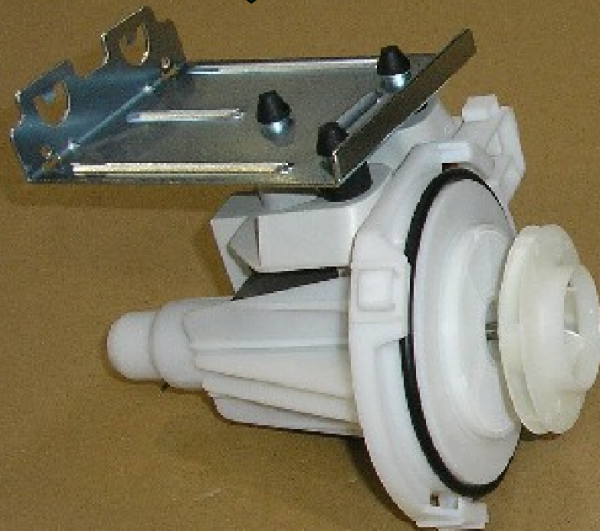
Service set MPH motor

In case of intervention leading to replacement of heating element code: 480131000096 or 480140102047 it is demanded to replace also MPH motor set in all appliances produced till week 17 year 2010.

480131000166
480131000169
480131000168
480131000112

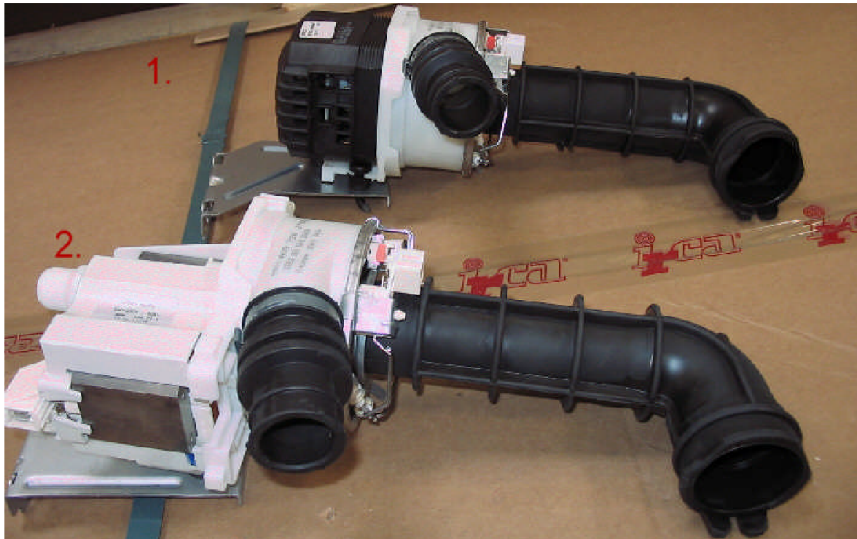
On the picture above motors with integrated heaters are shown:
1. Variable Speed Motor (VSM), 2. Single Speed Motor (MPH).

In case of heater replacement due to open thermal fuse, when inside heater can be found calcium/limestone layer caused by hard water please check if:

Calcium/limestone deposition that builds up on heater is limiting heat transfer from heater to water and forcing thermal protectors to react. In longer time the irreversible protector is tripped. Reducing/eliminating calcium (caused by not softened water) build-up will avoid such cases.

1. Water hardness setting on Dishwasher is correctly set, if necessary increase water hardness setting.
2. In case of multifunction detergent (tablets "X" in 1) used in area with hard water, instruct customer that salt has to be added in addition to multifunction detergent.

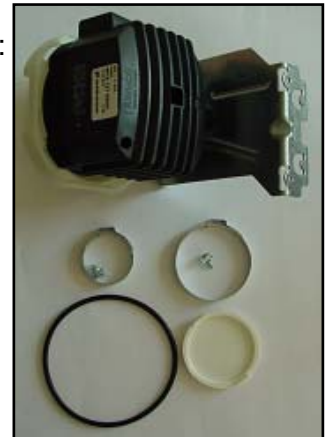
4801 401 02394

- suite à des surcharges de produits lessiviels, il peut arriver que des résidus de lessive viennent petit à petit réduire les performances de la pompe de cyclage ce qui provoque une surchauffe de la résistance 481225928925 remplacé par : 480131000096. (Fusible fondu). Dans ce cas particulier, il est recommandé de changer la pompe de cyclage en plus de la résistance.

- La Pompe de Cyclage : **4801 401 02394**

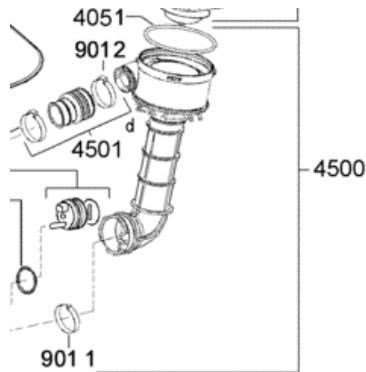
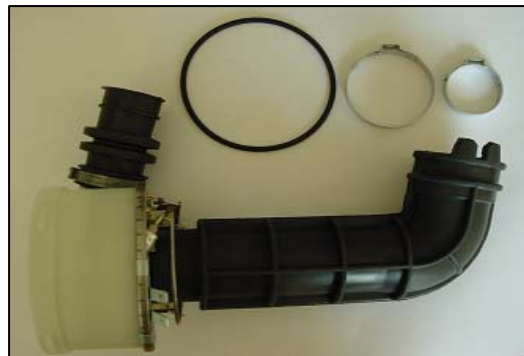
Code service de la résistance 4812 259 28925 remplacée par : 480131000096.
Si vous commandez ce code vous recevrez uniquement :
