Service Bulletin 4812 718 40309**AUTHOR:** Alicja Malinowska**Last Update:** 03/30/11**VERSION:** 1.0**TITLE:** Integrated heating element Euro/UK (Motor Pump Heater MPH)**SUBJECT:** Integrated heating element Euro/UK replacement**REMEDIAL ACTION**

Service Bulletin 4812 718 40316

TITLE: Open Fuse occurring at integrated heaters used for Motor-Pump-Heater (MPH), and Variable Speed Motor (VSM).

SUJET : Fusible de résistance fondue

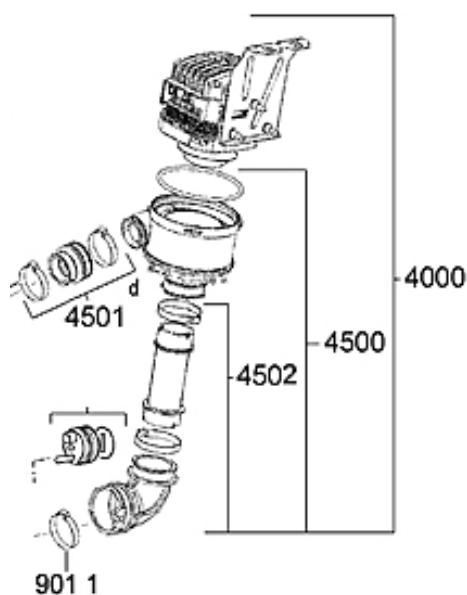
Ex : ADP 6946

Vous trouverez ci-dessous deux représentations différentes de ces pièces dans les SM.

- suite à un problème sur le relais de chauffage la résistance est alimentée à vide. Pour tester le relais de chauffage mettre l'appareil sous tension, fermer la porte de l'appareil et prendre la tension aux bornes de la résistance. En l'absence de l'alimentation de la bobine du relais de chauffage, une tension totale ou partielle aux bornes de la résistance est significative d'un relais défectueux. Dans ce cas particulier, il est recommandé de changer le relais de chauffage en plus de la résistance.
